Manhole Inspection Summary

Manhole # S19A1_018MH

Insp Date: **6/2/08 11:55 AM**

Location Address: **1930 carroll st**

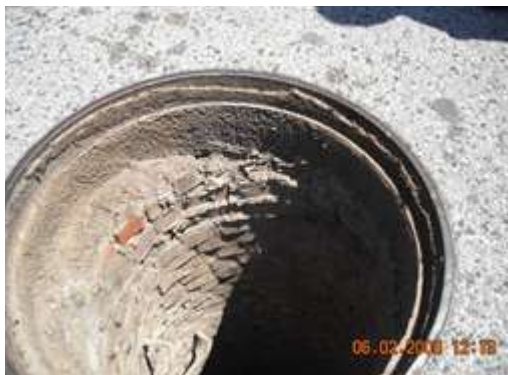
misc

Subject To Ponding: **Sheeting**

inflow evidence from sheeting

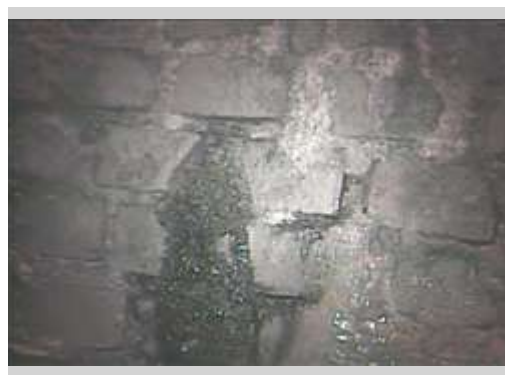
Defect 5

Infiltration: ☐ None ☐ Joint ☐ Cracks ☐ Mortar ☐ Roots ☒ **Wall**

infiltration @ barrel wall

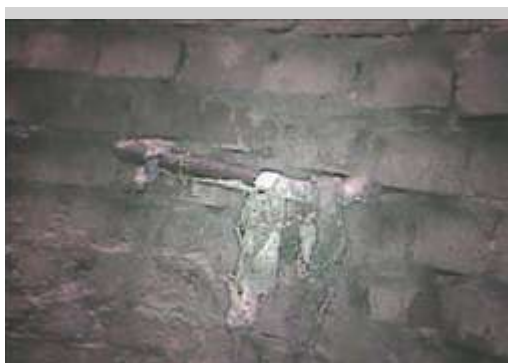
Defect 4

☒ **Evidence Of Surcharge** Depth: **3** (ft.) ☐ Active Surcharge Present

surcharge evidence

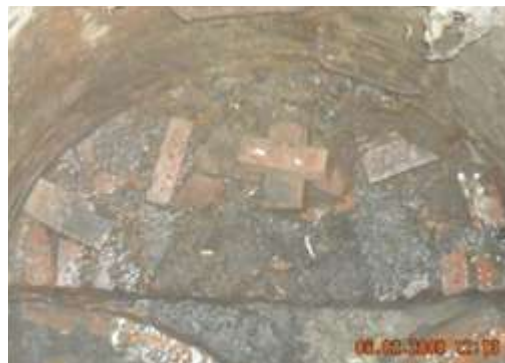
Defect 3

Condition: ☐ Sound ☐ Cracked ☐ Root Intrusion ☐ Deteriorated ☐ Leaks ☒ **Debris**

debris on bench

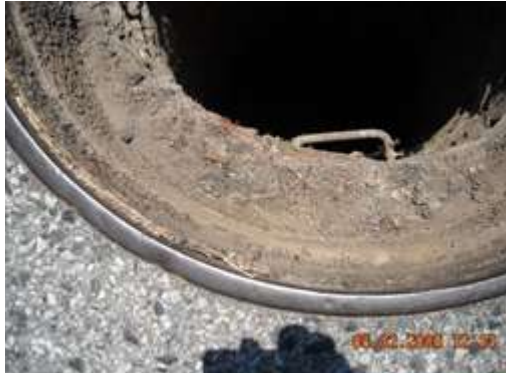
Defect 1

Offset: **3.5** (in.)

frame offset

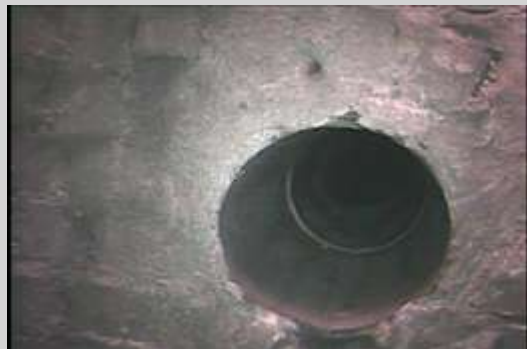
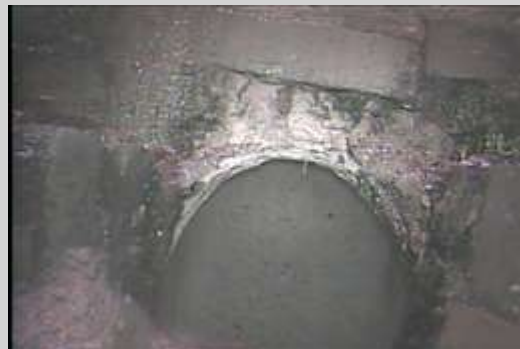
9 O'Clock Inflow

Infiltration: **Evidence** Pipe Seal Cond: **Cracked**

Drop: **Outside** Rod and Bar
